# Water Injectors - K28 Case Study and More

Director of Well Abandonment & Integrity  
Conocophillips

# K-28 - a newly delivered well that was looking bad!

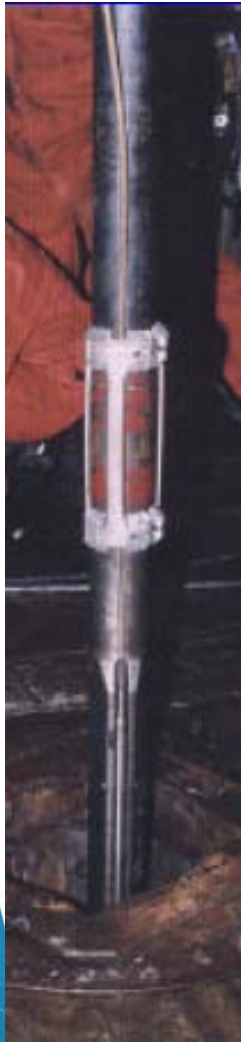
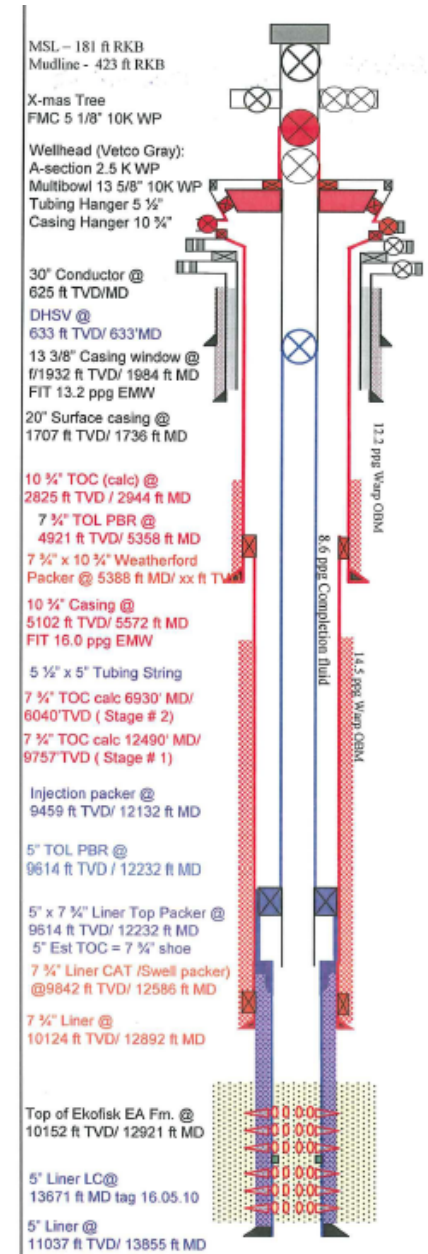
- K28A was sidetracked and completed in May 2010. No faults detected in construction phase
- After few months of injection and Summer SD, annulus pressure came up.
- One annulus bleed off test produced "crude looking" fluid.
- There was no leak detected in the tubing.
- Due to B annulus problem, the well was considered as P&A candidate.

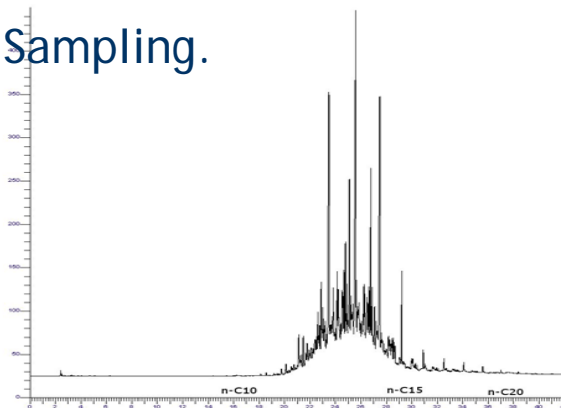
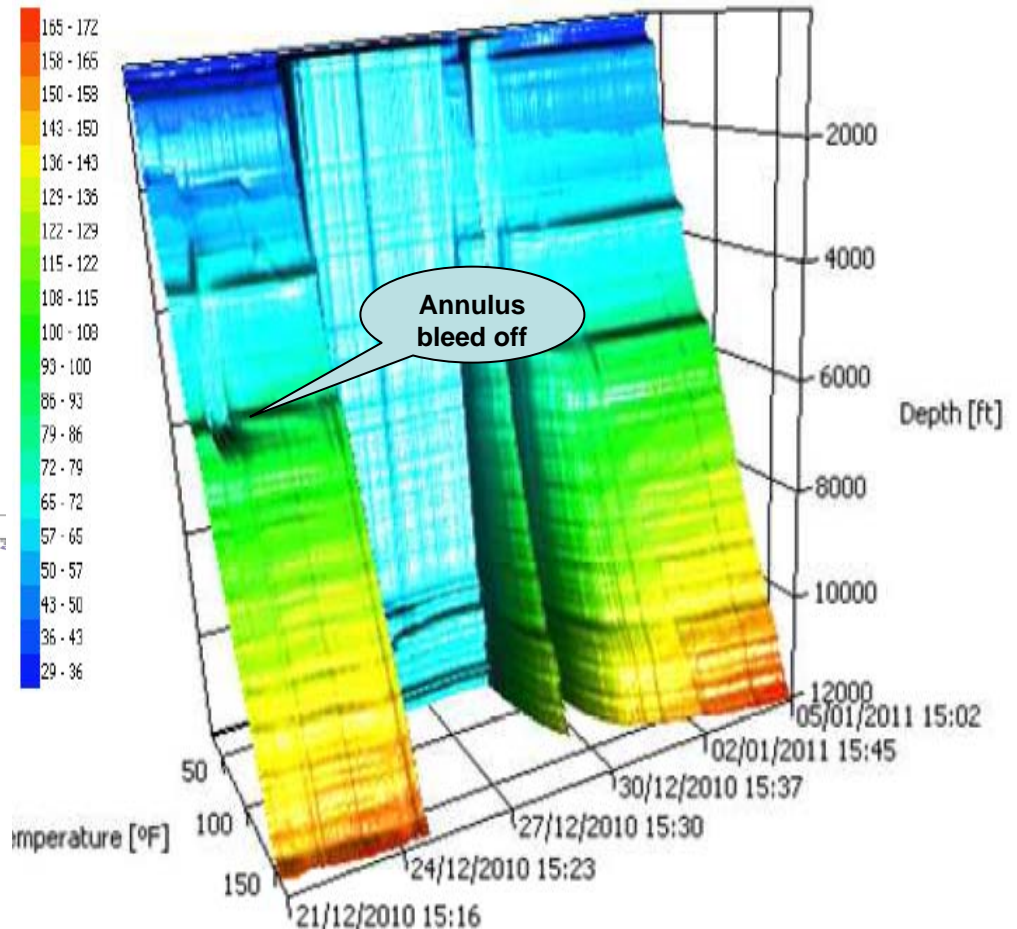
Distributed Temperature System

- Behaviour under injection,
- Behaviour during bleed off

Thanks to DTS survey, root cause of annulus leak has been diagnosed to be result of expansion of trapped drilling fluid (OBM) at the liner lap.

Fluid moves downwards during bleed-off.

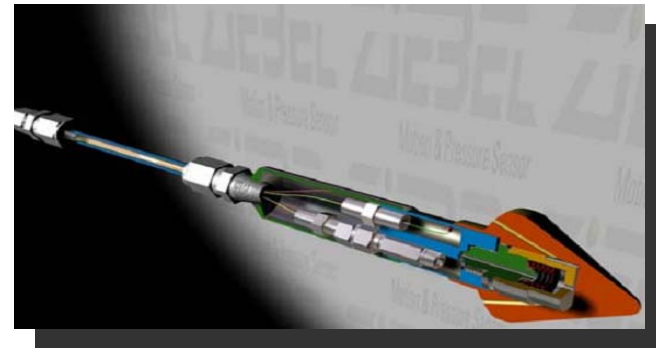
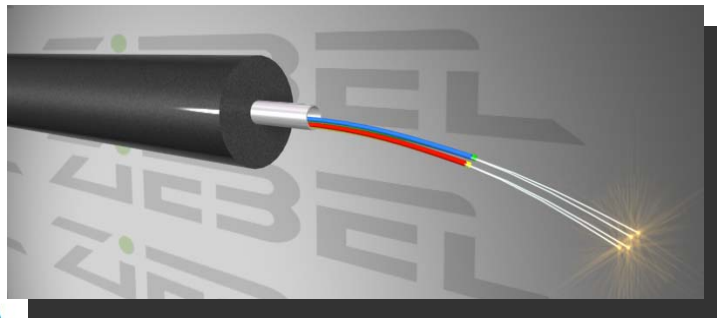
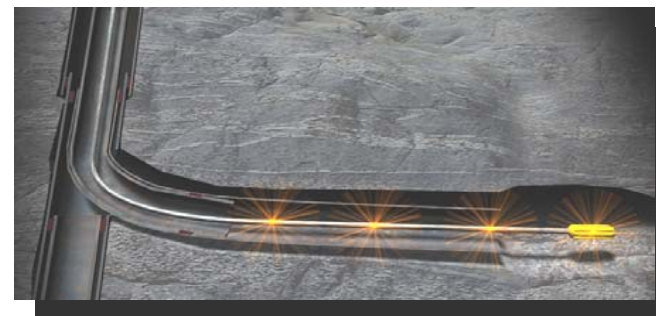
- Provides a step change in downhole intervention & horizontal well logging
  - Similar to coiled tubing intervention, but utilizing much smaller footprint equipment
  - Requires 6-8 field crew vs. other solutions requiring 10+ engineers for 24hr operation.
- A 20,000 ft. injectable semi-stiff, continuous, carbon “rod” with Fibers
  - Significantly less choke effect compared with using CT or “tractor”
  - Doesn’t require any up-down movements to log entire wellbore

DTS & DAS measurements along the complete length of the “rod” with point pressure, temperature & vibration sensors housed in a “bullnose” BHA.

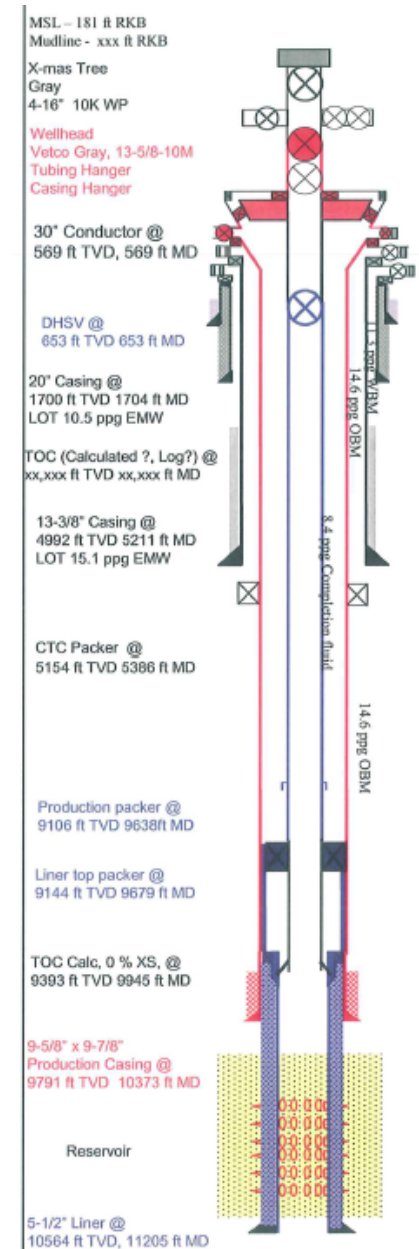
- Built in the years when we did not cement the production casing (to improve well integrity).
- Some material specification issues on wellhead caused corrosion.
- CTC packer in open hole on a water injection in a subsiding field.

B annulus pressure - with wellhead concerns!  
 Traditional solution - cement the reservoir and sidetrack the well.

Ziebel logging identified main flow into B was NOT from the reservoir.

**Workover.....**
